Intel[®] Ethernet Controller I210

Specification Update

Revision 2.8
332763-012

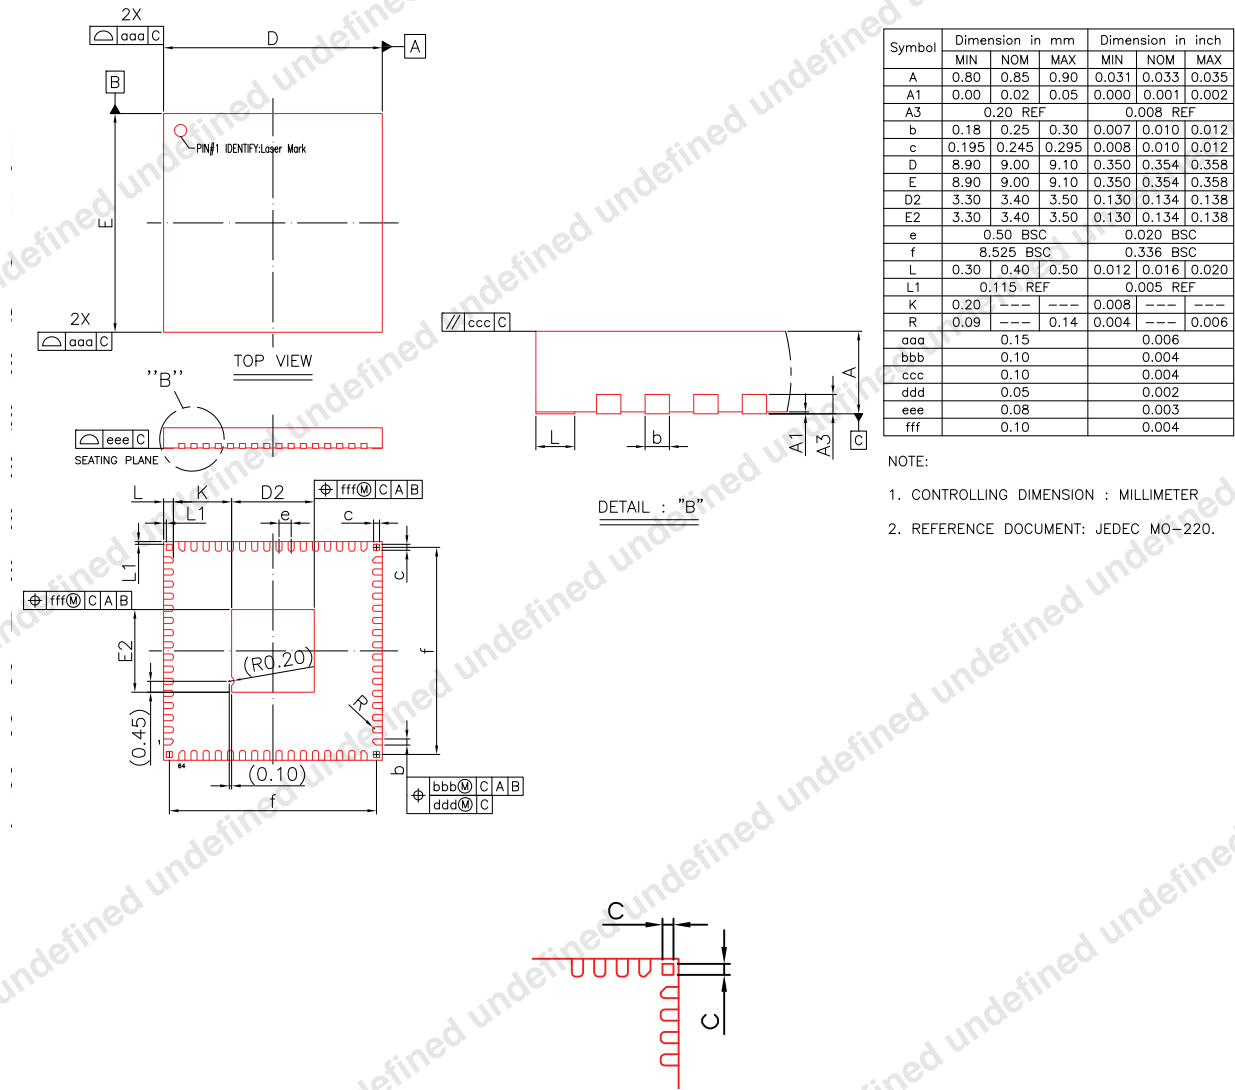
7. WGI210CS Automotive Industrial Temperature Fiber Schematic

Note: The I210 CS has four no-connect corner pads for added solder joint reliability (as shown in Detail C).
