# MegaCore IP Library

## Release Notes and Errata

RN-IP-7.3

10.1  
March 2011

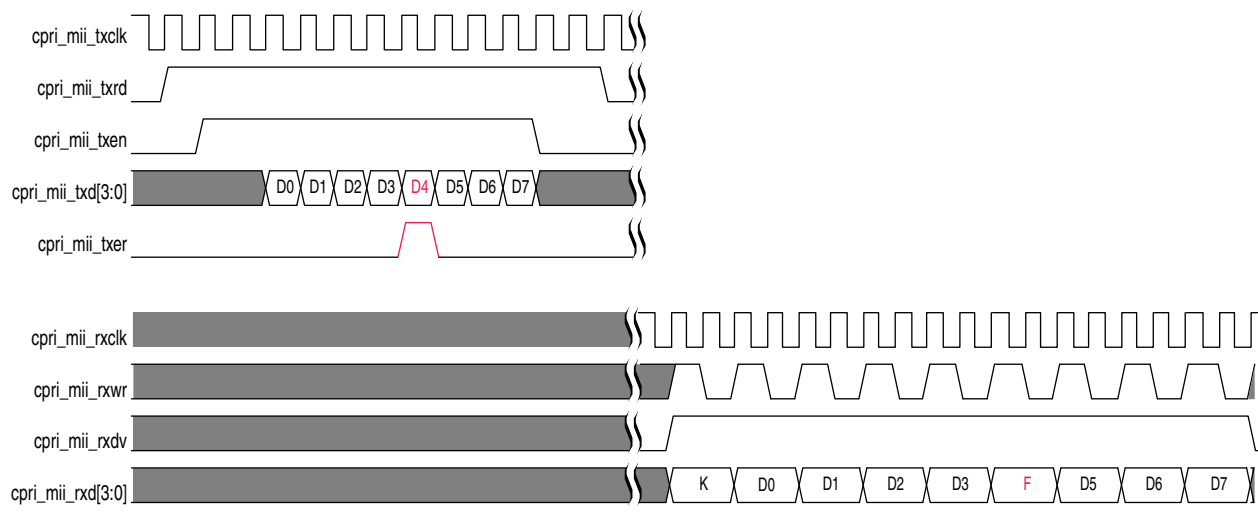
**Figure 6-1. Corrected CPRI MII Interface Signals on Transmitting RE or REC Master and on Receiving RE Slave**

Figure 4-26, CPRI MII Interface Signals on Transmitting RE or REC Master and on Receiving RE Slave, also shows this behavior. Replace Figure 4-26 on page 80 of the *CPRI MegaCore Function User Guide* with the following [Figure 6-1](#).

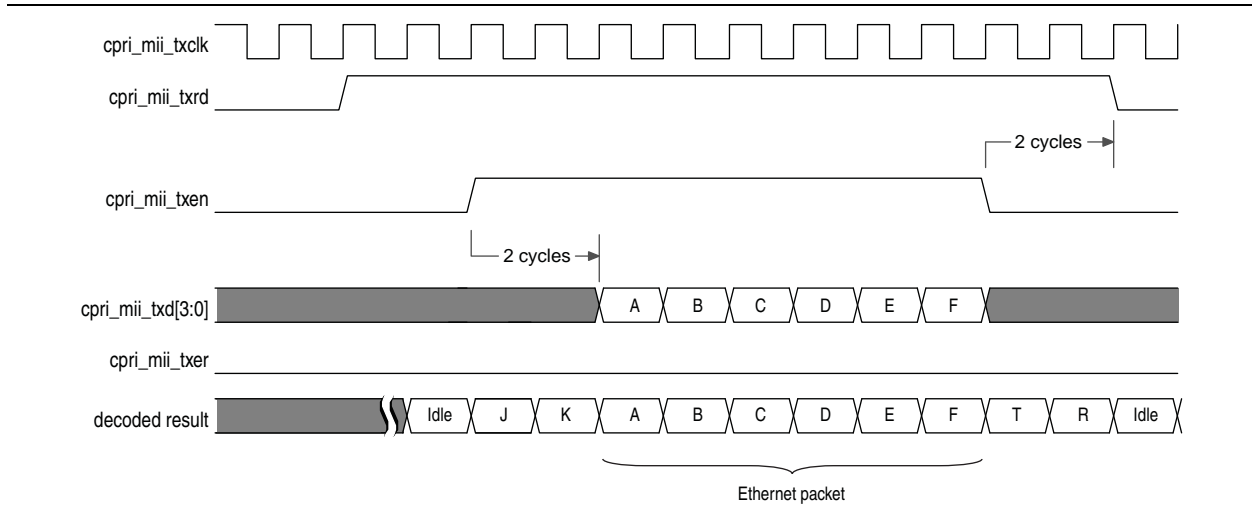
**Figure 6-2. Corrected CPRI MII Interface Transmitter Example**

The *CPRI MegaCore Function v9.1SP1 User Guide* contains erroneous information about the MII interface. Figure 4-16 and Figure 4-17 in the *CPRI MegaCore Function User Guide* should be replaced with the figures in this erratum.

Although [Figure 6-2](#) shows `cpri_mii_txd` asserted continuously during transmission of an Ethernet packet on `cpri_mii_txd`, this is not always the case. The CPRI MII Interface transmitter can deassert `cpri_mii_txd` while `cpri_mii_txen` is still asserted, to backpressure the external Ethernet block. If this happens, the Ethernet block must deassert `cpri_mii_txen` on the following cycle, to prevent the MII Interface transmitter buffer from overflowing. The `cpri_mii_txen` signal should remain deasserted until the cycle following reassertion of `cpri_mii_txd`. If `cpri_mii_txen` is not reasserted in the cycle following the reassertion of `cpri_mii_txd`, then an Idle cycle is inserted in the packet; therefore, the external Ethernet block must reassert `cpri_mii_txen` in the cycle following reassertion of `cpri_mii_txd`.

Replace Figure 4-16 on page 56 of the CPRI MegaCore Function User Guide with the following [Figure 6-2](#).

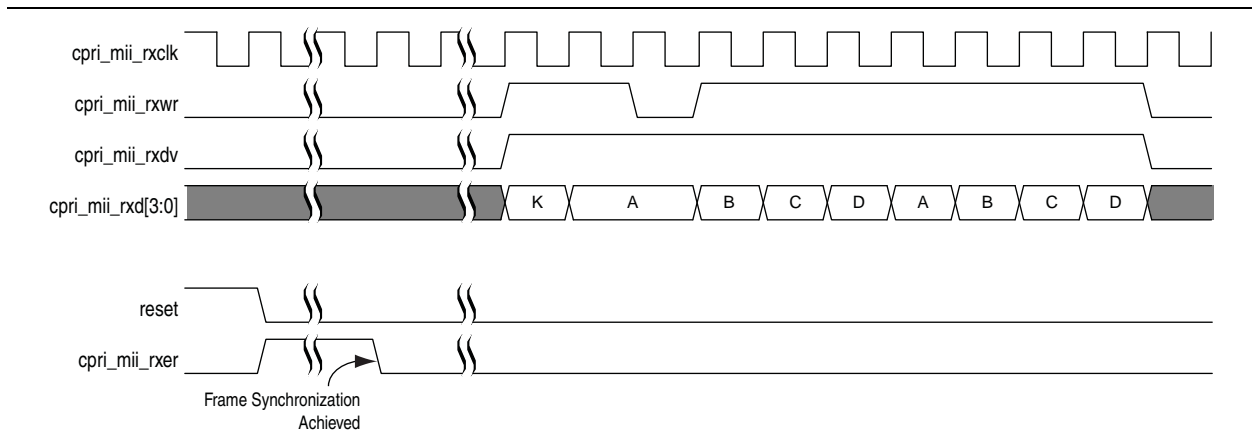
**Figure 6-3. Corrected CPRI MII Interface Receiver Example**

The CPRI MII Interface receiver transmits the K nibble to indicate start-of-frame on the MII interface. Replace Figure 4-17 on page 57 of the CPRI MegaCore Function User Guide with the following [Figure 6-3](#).

The J nibble of the start-of-frame is consumed by the CPRI MegaCore function, and is not transmitted on the MII interface.

The corrections indicated above apply to Figure 4-18 on page 57 of the CPRI MegaCore Function User Guide as well.

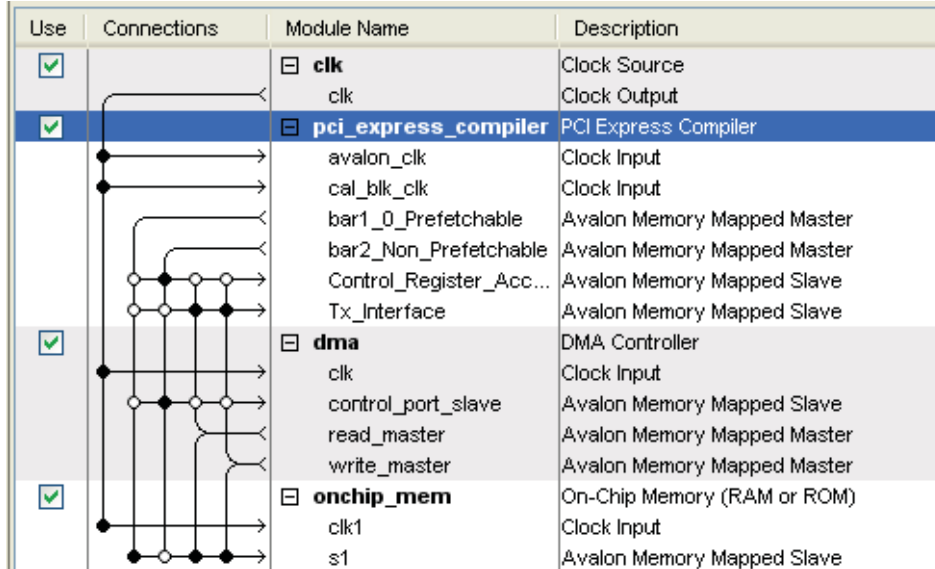
**Figure 20-1. System Port Connections**

This is a documentation error only. Figure 20-1 illustrates the correct connections.

No workaround is required. Make the connections described “Table 16-6 SOPC Builder Connections” of the *PCI Express Compiler User Guide*
