Intel[®] Ethernet Controller I210

Specification Update

Revision 3.0
332763-014

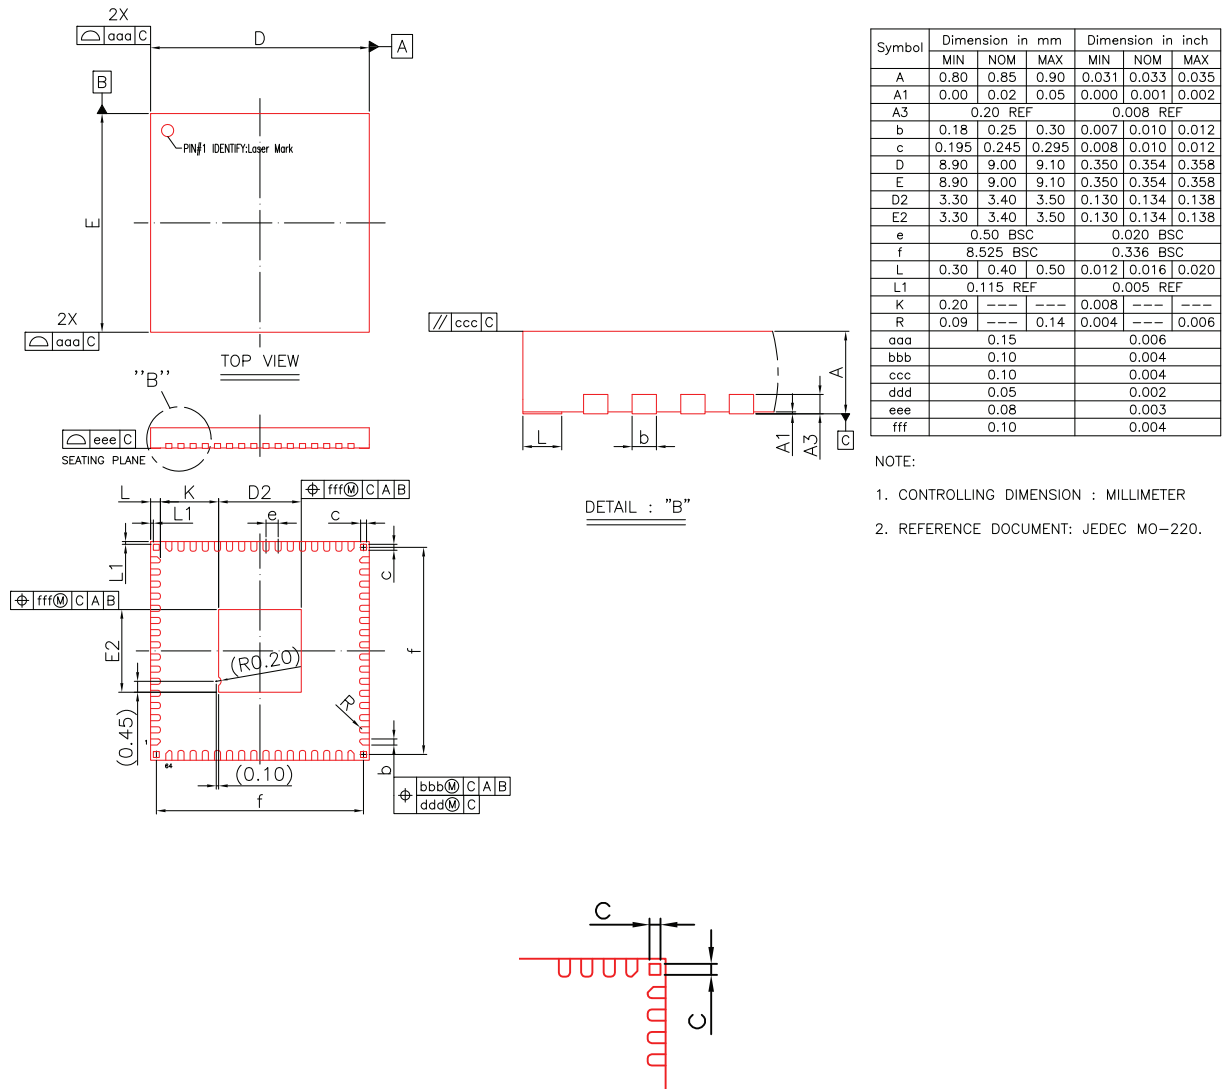
7. WGI210CS Automotive Industrial Temperature Fiber Schematic

Note: The I210 CS has four no-connect corner pads for added solder joint reliability (as shown in Detail C).
