# Intel<sup>®</sup> Ethernet Controller I350

**Specification Update**

Revision 3.1  
333066-005

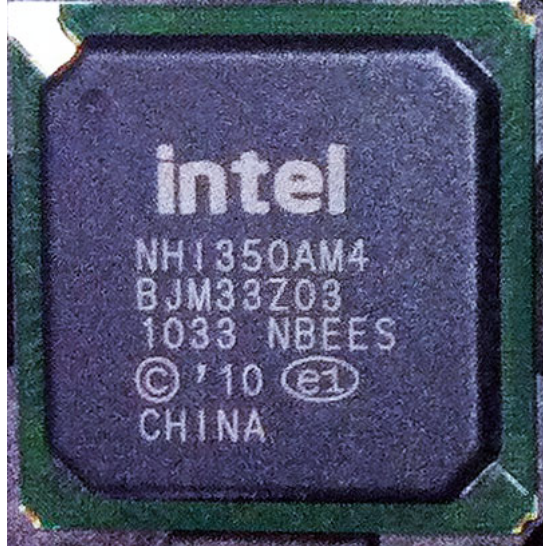
**Figure 1-1. Example Component with Identifying Marks**

## 1.2 Marking Diagrams
