7th and 8th Generation Intel® Core™ Processor

Specification Update

Revision 016

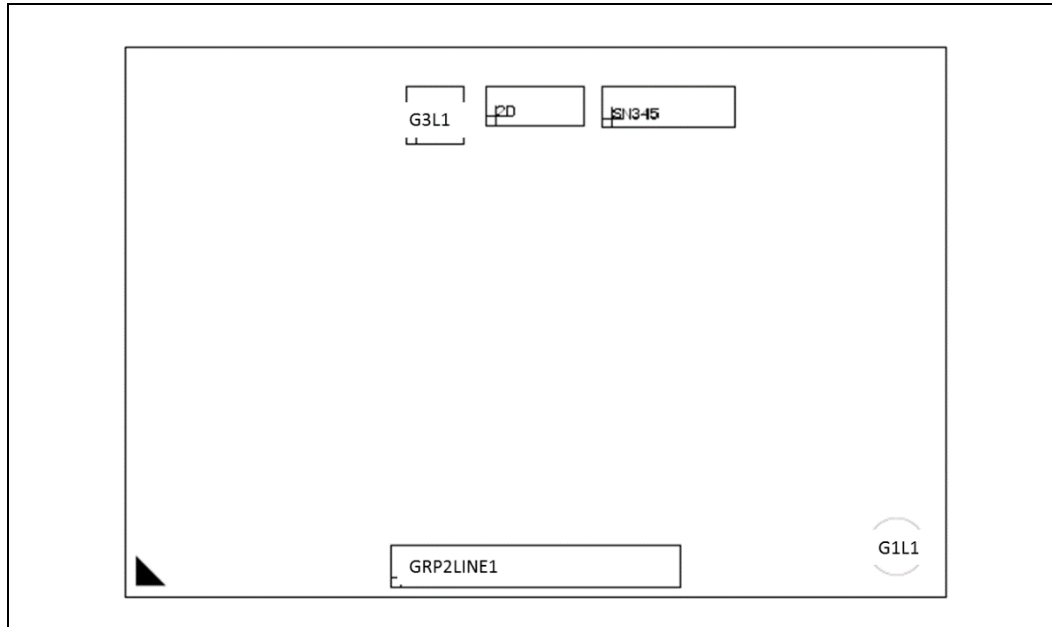
Pin Count: 1440

Package Size: 42 mm x 28 mm

GRP1LINE1 (G1L1): {eX}
 GRP2LINE1: FPOxxxxxSSPEC
 GRP3LINE1 (G3L1): Intel logo

| Figure 4. H-Processor Line BGA Top-Side Markings | 12 |
