Intel Atom[®] Processor E3800

Specification Update

(Formerly Bay Trail -I SoC)

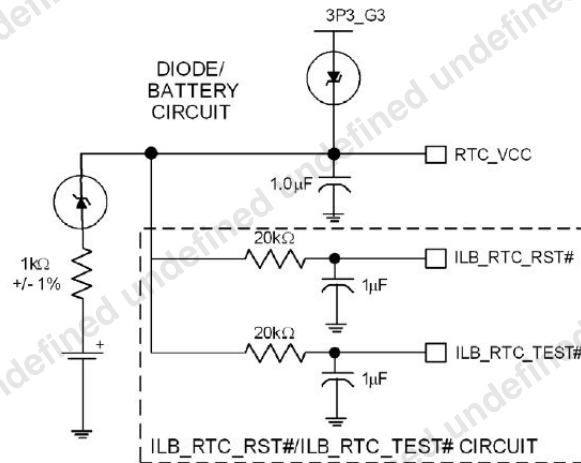
2. ILB_RTC_TEST# and ILB_RTC_RST# RC Time Delay Calculation Formula

The RC delay between RTC_VCC to ILB_RTC_TEST and ILB_RTC_RST, Figure 21-4 in Section 21.2.3 of the PDG (Doc ID #512379) is obtained by using the formula $t = -\ln((RTC_VCC - V_{ih\ min})/RTC_VCC) * R * C$ and the added circuit is as follows:

The SoC RTC requires some additional external circuitry. The ILB_RTC_RST# and ILB_RTC_TEST# signals are used to reset the RTC well. The external capacitor and the external resistor between ILB_RTC_RST#/ILB_RTC_TEST# and RTC battery (VBAT) were selected to create an RC time delay, such that ILB_RTC_RST# and ILB_RTC_TEST# go high sometime after the battery voltage is valid. The RC time delay should be in the range of 18-25 ms. When ILB_RTC_TEST# is asserted, bit 2 (RTC_PWR_STS) in the GEN_PMCON_1 (General PM Configuration 1) register is set to 1, and remains set until software clears it. Hence, when the system boots, the BIOS recognizes that the RTC battery is removed.
