10th Generation Intel® Core™ Processor

Specification Update

Supporting 10th Generation Intel® Core™ Processor, Intel® Pentium® Processor, and Intel® Celeron® Processor for U, H, and S Processor Line Platforms, formerly known as Comet Lake

Revision 013

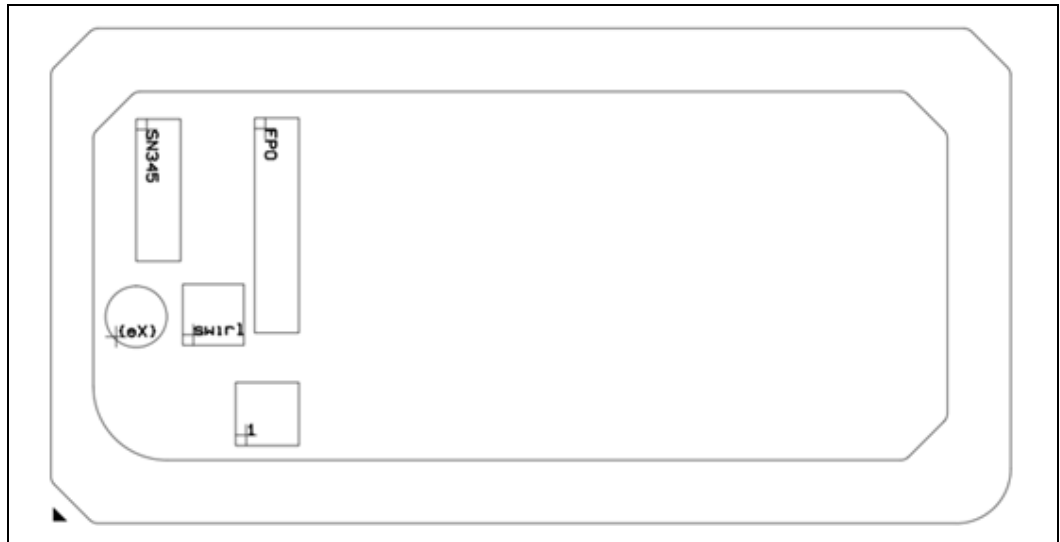
Pin Count: 1528 and Package

Size: 46 mm x 24 mm

Figure 1. U-Processor Line Multi-Chip Package BGA Top-Side Markings	8
Figure 2. H-Processor Line Multi-Chip Package BGA Top-Side Markings	9
Figure 3. S-Processor Line Multi-Chip Package BGA Top-Side Markings	10
