# **11<sup>th</sup> Generation Intel<sup>®</sup> Core<sup>™</sup> Processor**

## **Specification Update**

***Supporting 11<sup>th</sup> Generation Intel<sup>®</sup> Core<sup>™</sup> Processor, Intel<sup>®</sup> Pentium<sup>®</sup> Processor, and Intel<sup>®</sup> Celeron<sup>®</sup> Processor for UP3, UP3 IOT, UP4, H35, H81, UP3-Refresh, and H35-Refresh Processor Line Platforms, formerly known as Tiger Lake***

***Revision 027***

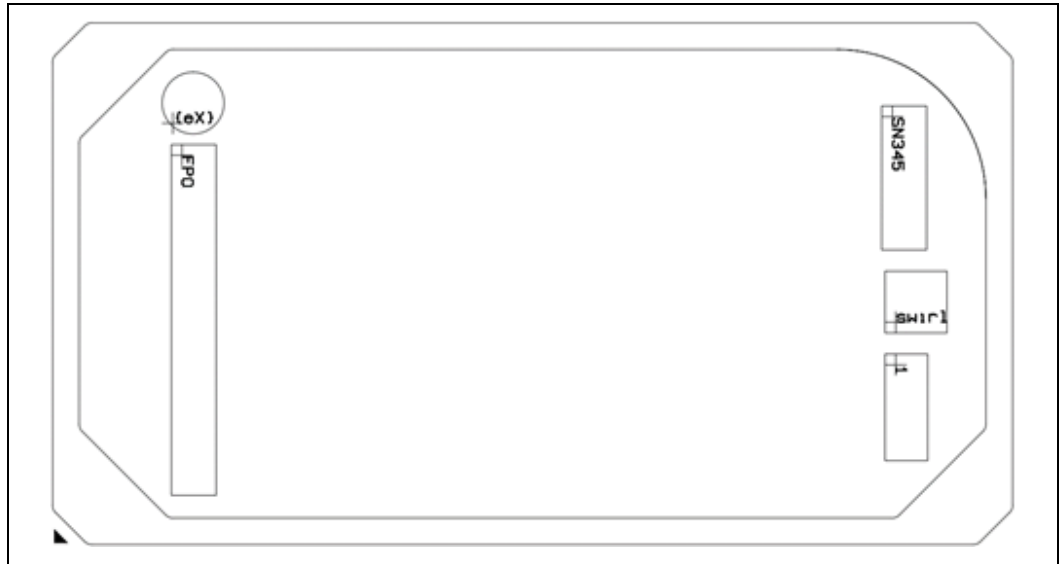
**Figure 1. Processor Based on UP3/H35/UP3-Refresh/H35-Refresh Processor Line Multi-Chip Package BGA Top-Side Markings**

Pin Count: 1449

Package Size: 45.5 mm x 25 mm

**Note:** "1" is used to extract the unit visual ID (2D ID).
