Mobile/Desktop 5th Generation Intel® Core™ Processor Family

Specification Update

*Supporting the 5th Generation Intel® Core™ Processor based on
Mobile H-Processor Line and Desktop H-Processor Line*

Revision 024

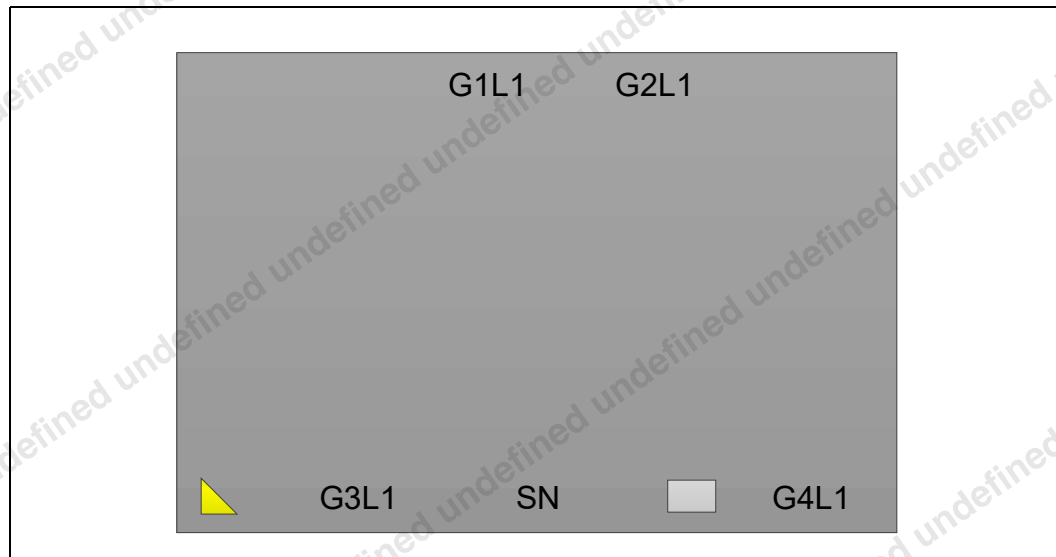
Figure 1. Mobile H-Processor Line BGA Top-Side Markings

The processor stepping can be identified by the following component markings.

Pin Count: 1364 Package Size: 37.5 mm x 32 mm

Production (SSPEC) Maximum Characters/Line:

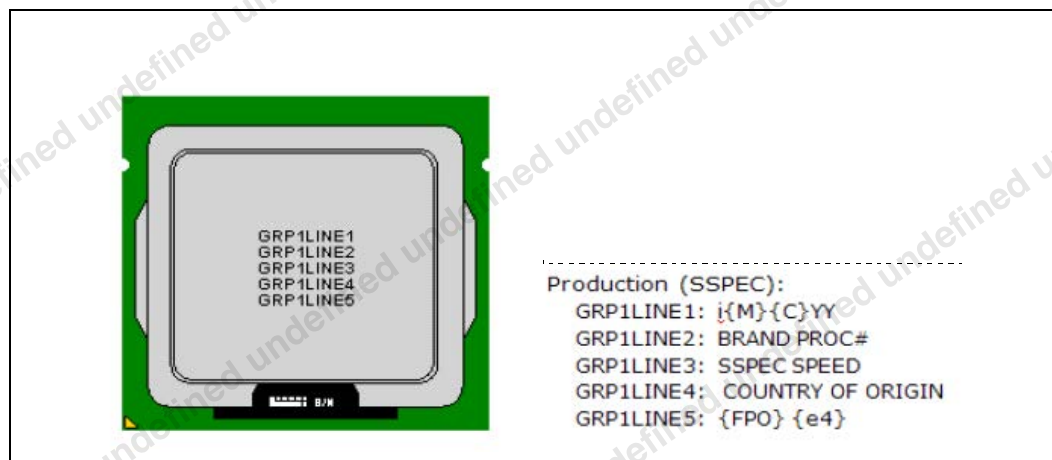
Figure 2. Desktop H-Processor Line LGA Top-Side Markings

Pin Count: 1150 Package Size: 37.5 mm x 37.5 mm
