Introduction

The SerialLite II MegaCore® function is a lightweight, chip-to-chip protocol suitable for both packet and streaming data in chip-to-chip, board-to-board, and backplane applications. It offers low protocol overhead, low gate count, and minimal data transfer latency. It provides reliable, high-speed transfers of packets between devices over serial links. The SerialLite II protocol defines packet encapsulation at the link layer, and data encoding at the physical layer. The protocol integrates transparently with existing networks, without software support.

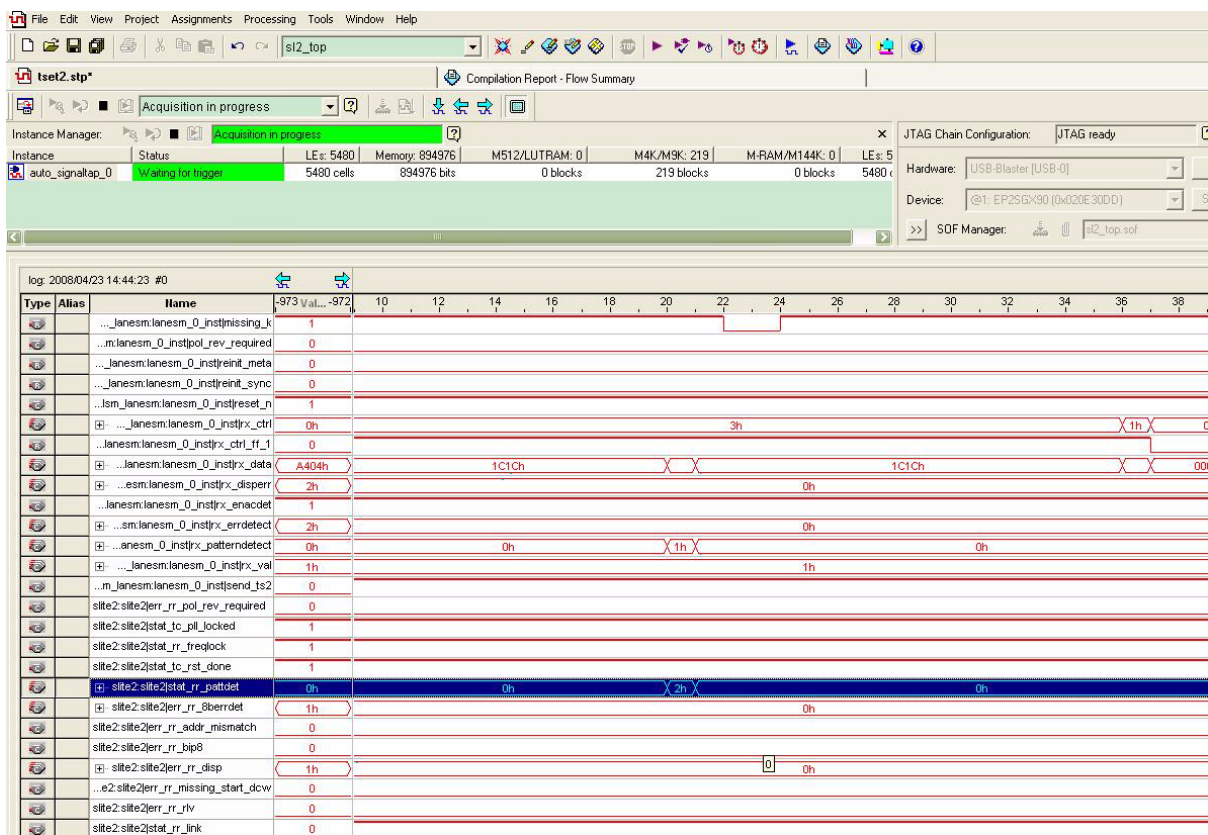
The Quartus® II SignalTap® II Logic Analyzer debugging shows the behavior of this signal as shown in Figure 1. The `stat_rr_pattdet` signal is asserted once a comma character is detected on the lane.

Figure 1. SignalTap II Logic Analyzer showing `stat_rr_pattdet` Signal

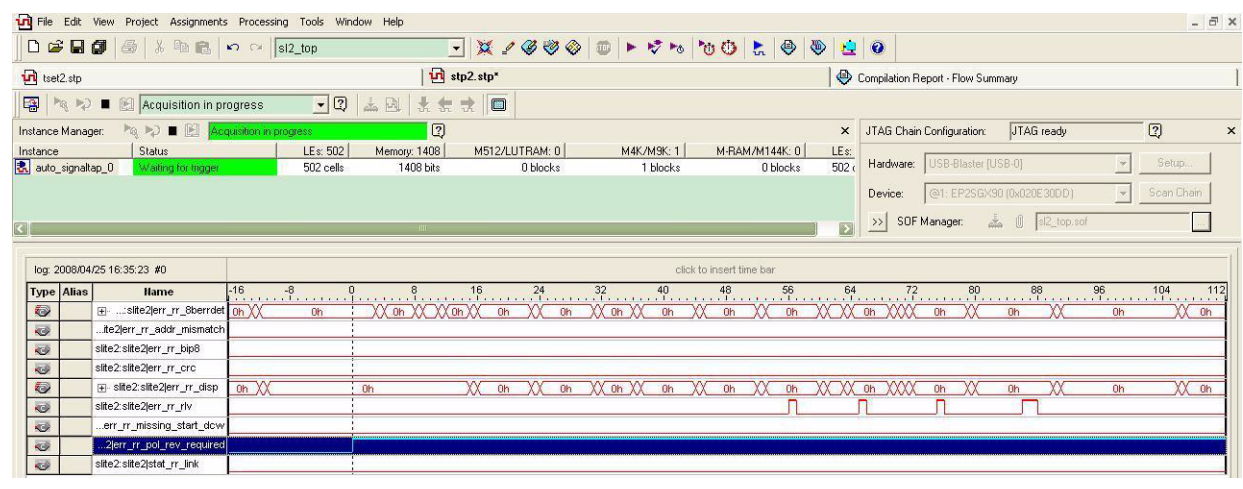
The Quartus II SignalTap II Logic Analyzer debugging shows the behavior of the `err_rr_pol_rev_required` signal as shown in Figure 2.

Figure 2. SignalTap II Logic Analyzer showing `err_rr_pol_rev_required` Signal

In the SignalTap II Logic Analyzer, you can see that when `err_rr_pol_rev_required` is asserted, `stat_rr_link` never goes high.

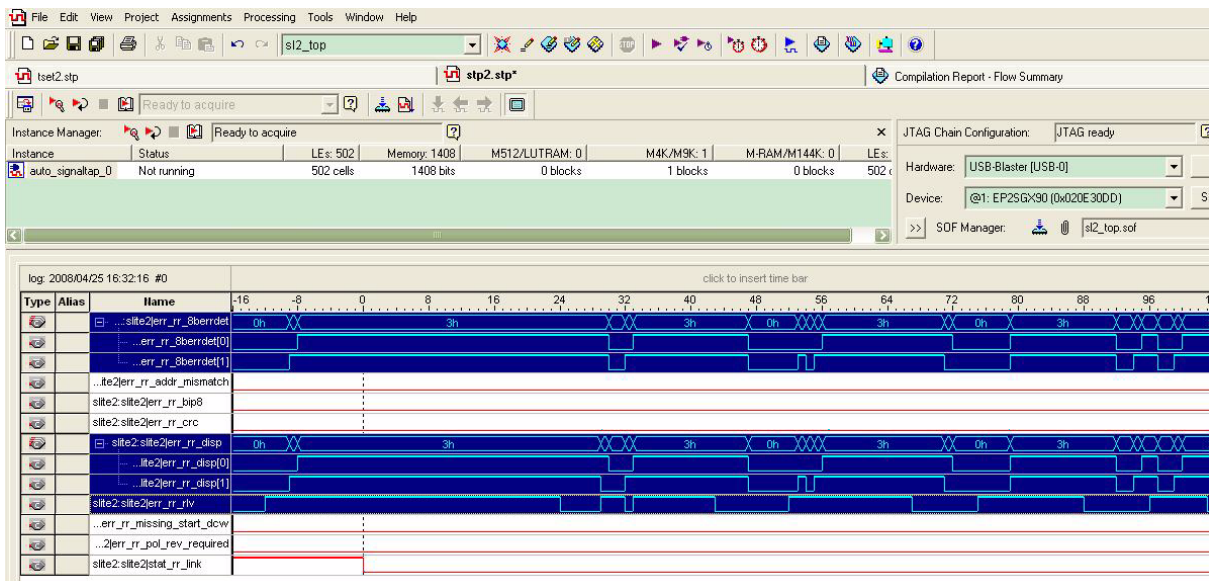
The Quartus II SignalTap II Logic Analyzer debugging shows some transceiver errors (`err_rr_disp` and `err_rr_8berrdet`) asserted causing the link to go down as shown in Figure 3.

Figure 3. SignalTap II Logic Analyzer showing Transceiver Errors
