12th Generation Intel[®] Core[™] Processor

Specification Update

Supporting 12th Generation Intel[®] Core[™] Processor for S, H, U, P, and HX Processor Line Platforms, formerly known as Alder Lake

Revision 025

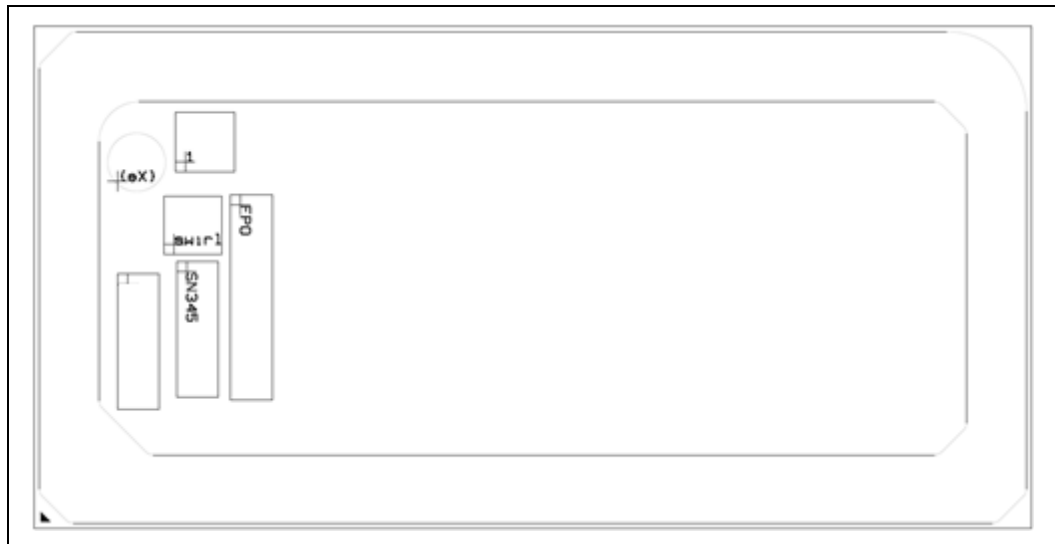
Figure 3. Processor Based on U15 Processor Line Chip Package BGA Top-Side Markings

Pin Count: 1744

Package Size: 50mm x 25mm
