13th Generation Intel[®] Core[™], Intel[®] Core[™] 14th Generation, Intel[®] Core[™] Processor (Series 1) and (Series 2), and Intel[®] Xeon[™] E 2400 Processor, and Intel[®] Xeon[™] 6300 Processor

Specification Update

Revision 020

February 2025

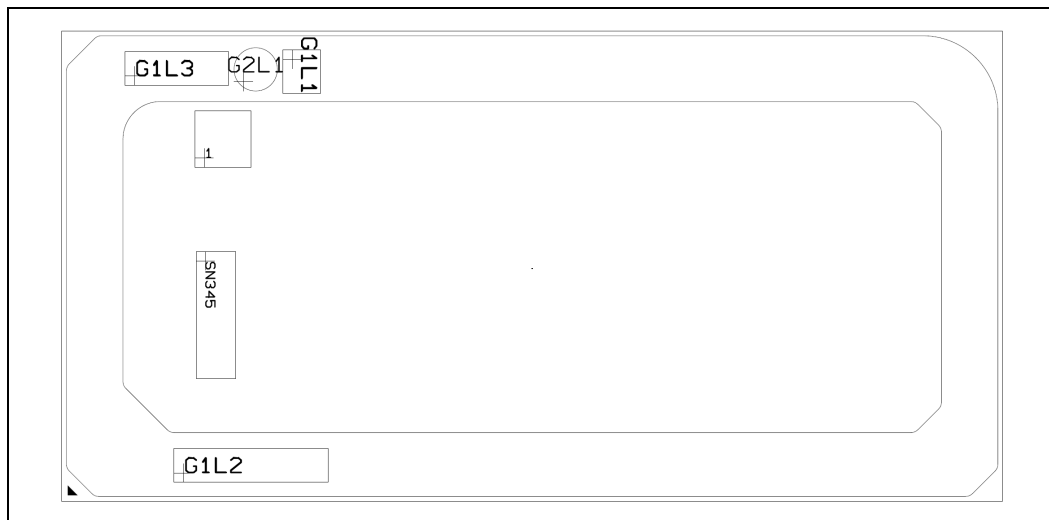
Figure 2-2. Processor Based on H/H-Refresh/P Processor Line Chip Package LGA Top-Side Markings

Pin Count: 1744

Package Size (width x height): 50mm x 25mm

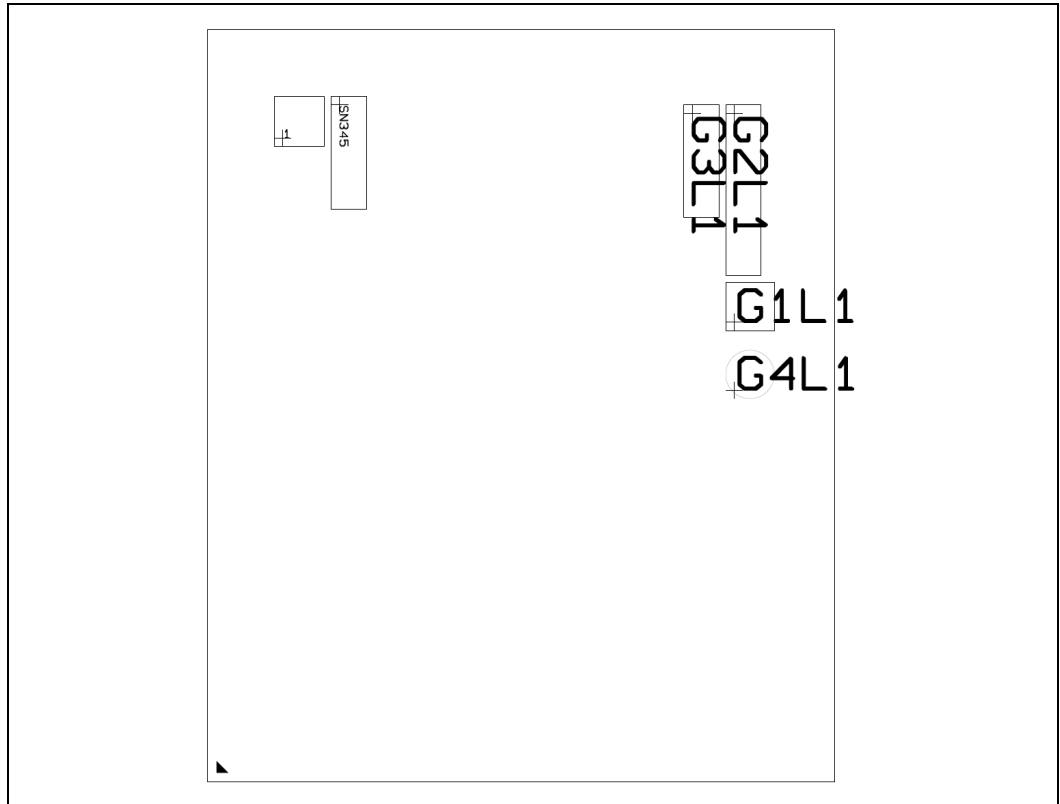
Figure 2-3. Processor Based on HX/HX-Refresh Processor Line Chip Package LGA Top-Side Markings

Pin Count: 1964

Package Size "(width x height)": 37.5mm x 45mm

Note: "1" is used to extract the unit visual ID (2D ID).

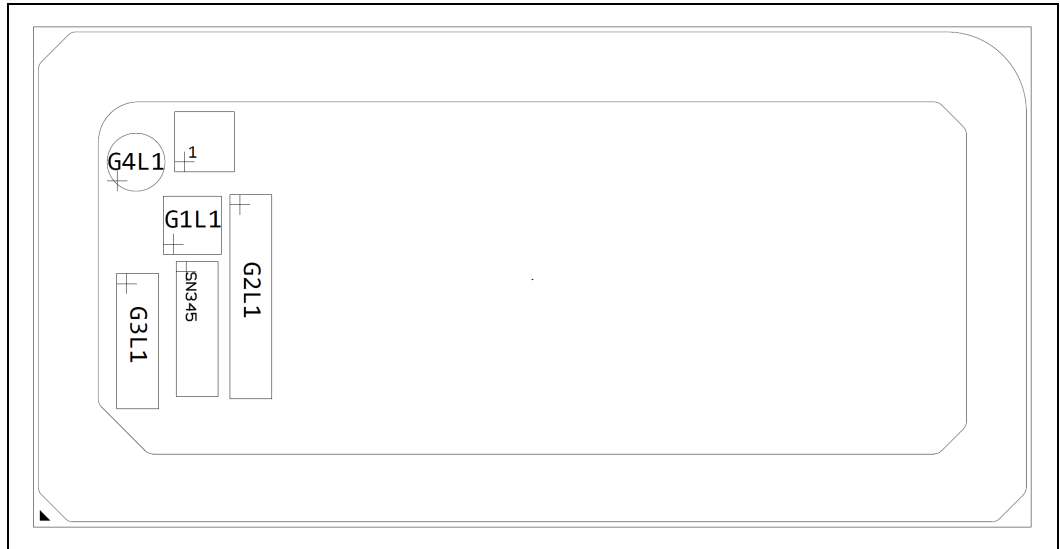
Figure 2-4. Processor Based on U/U-Refresh Processor Line Chip Package LGA Top-Side Markings

Pin Count: 1744

Package Size (width x height): 50mm x 25mm
