Intel® Core™ Ultra Processor

Specification Update

*Supporting Intel® Core™ Ultra Processors for H, U, and U
Type4 Series Platforms, formerly known as Meteor Lake*

Revision 012

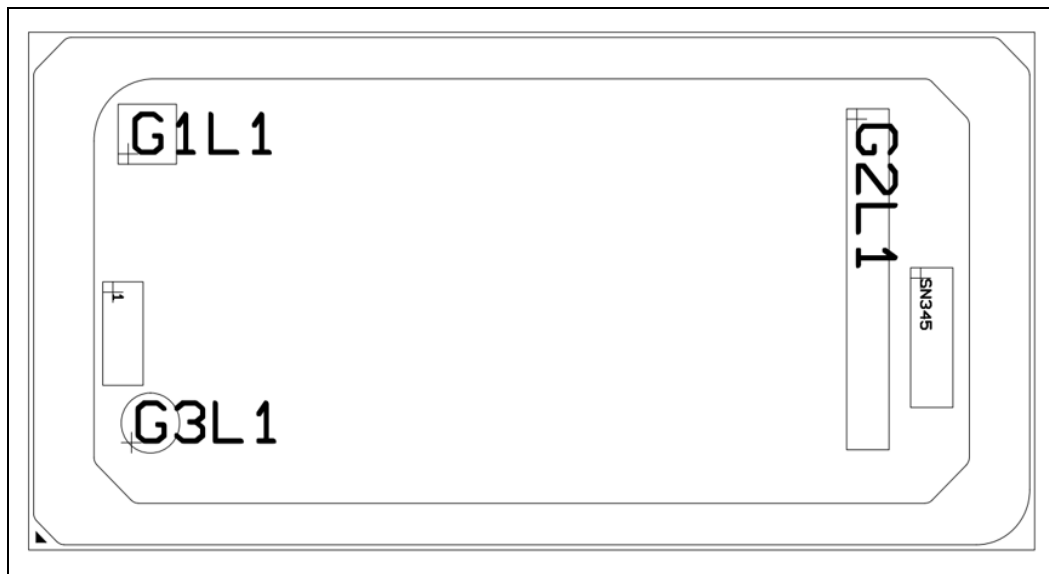
Figure 2-1. H/U-Series Chip Package BGA Top-Side Markings

Pin Count: 2049

Package Size (width x height): 50 mm x 25 mm

Production (SSPEC):

- SN345
- G1L1: SPARK
- G2L1: FPO_SSPEC
- G3L1: {ex}

Note: "1" is used to extract the unit visual ID (2D ID).

Figure 2-1. H/U-Series Chip Package BGA Top-Side Markings.....	8
Figure 2-2. U Type4 Series Chip Package BGA Top-Side Markings.....	9

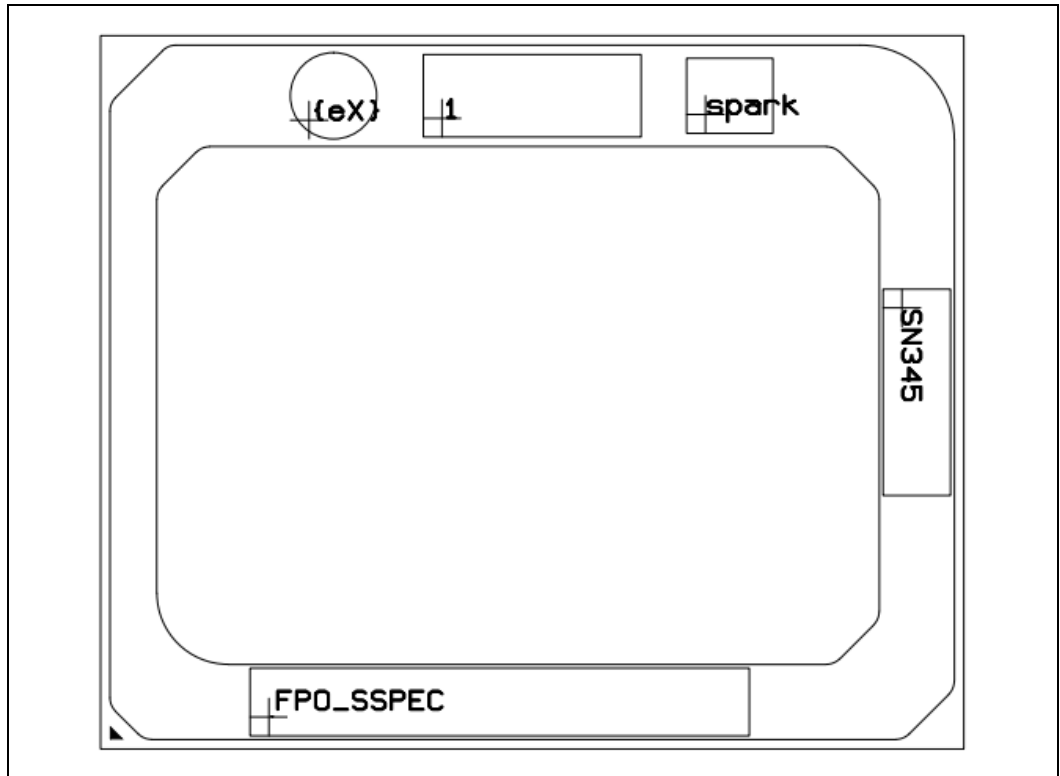
Figure 2-2. U Type4 Series Chip Package BGA Top-Side Markings

Pin Count: 2551

Package Size (width x height): 23 mm x 19 mm
