# **Intel® Core™ Ultra Processors (Series 2)**

**Specification Update**

***Supporting Intel® Core™ Ultra 200S, 200HX, 200H, and 200U  
Series Processors, formerly known as Arrow Lake***

***Revision 004***

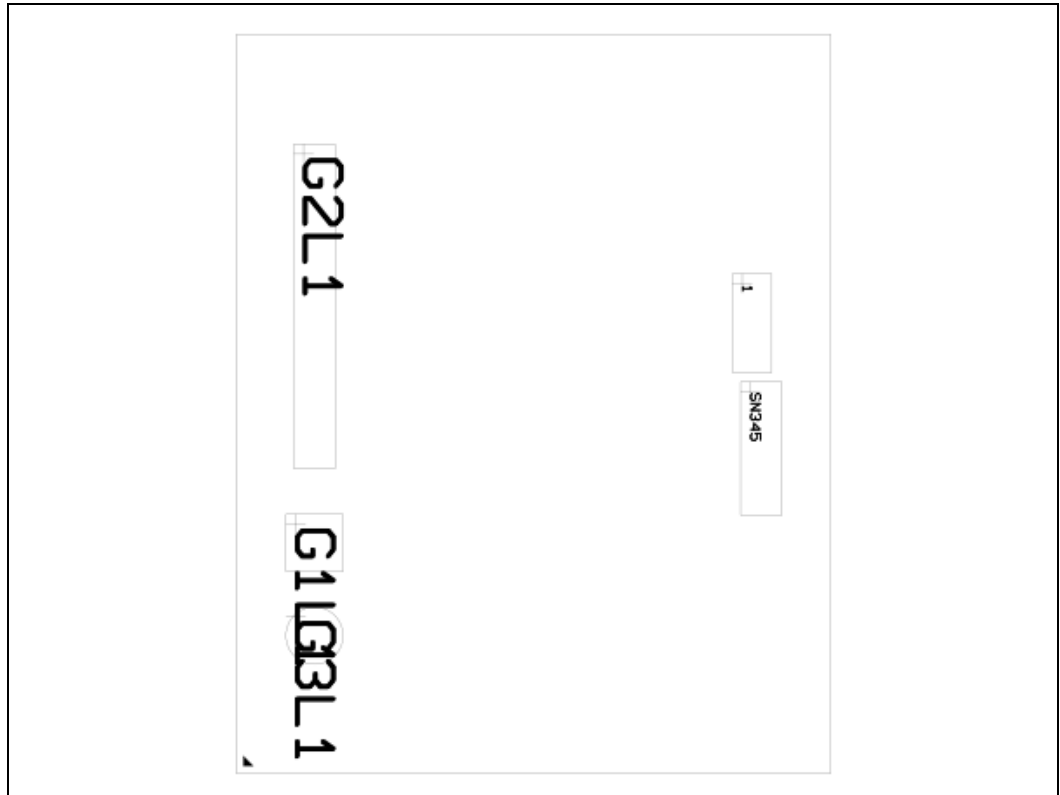
Figure 2-2. HX-Series Chip Package BGA Top-Side Markings

Pin Count: 2114

Package Size (width x height): 30.2 mm x 37.5 mm

**Note:** "1" is used to extract the unit visual ID (2D ID).
