N-series Intel[®] Pentium[®] Processors and Intel[®] Celeron[®] Processors

Specification Update

December 2019

Revision 018

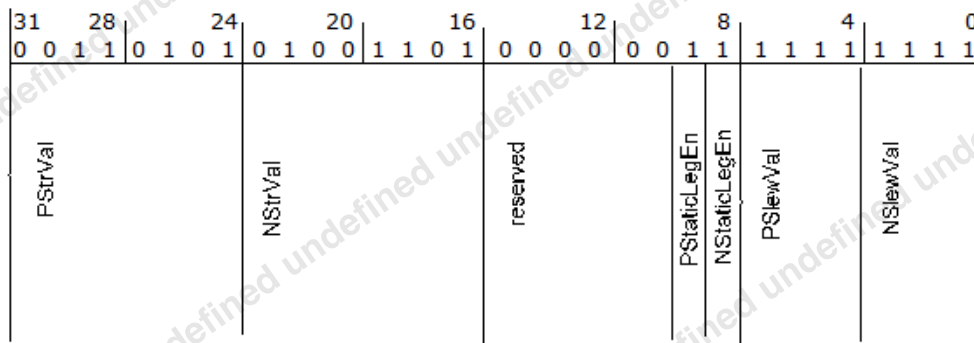
Bit range	Default and Access	Field Name (ID): Description
7:4 ¹	0xf RW	P Slew Value (PSlewVal): P Slew values for Pull-up settings.
3:0 ²	0xf RW	N Slew Value (NSlewVal): N Slew Values for Pull-down settings.

- Note:**
1. For LPC IO family, bits [5:4] are used to configure the PSlewVal, and bits [7:6] are reserved.
 2. For LPC IO family, bits [1:0] are used to configure the NSlewVal and bits [3:2] are reserved.

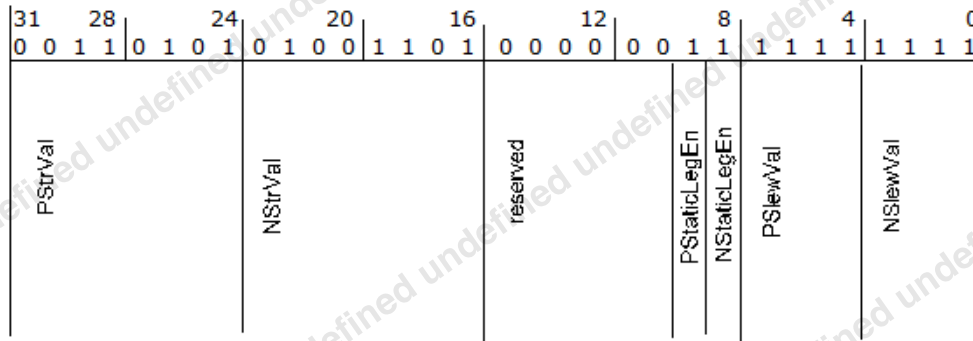
Bit range	Default and Access	Field Name (ID): Description
7:4 ¹	0xf RW	P Slew Value (PSlewVal): Slew values for Pull-up settings.
3:0 ²	0xf RW	N Slew Value (NSlewVal): Slew Values for Pull-down settings.

1. For SD card IO family, bits [5:4] contain the PSlewVal, and bits [7:6] are reserved.
2. For SD card IO family, bits [1:0] contain the NSlewVal and bits [3:2] are reserved.
