N-series Intel[®] Pentium[®] Processors and Intel[®] Celeron[®] Processors

Specification Update

December 2019

Revision 018

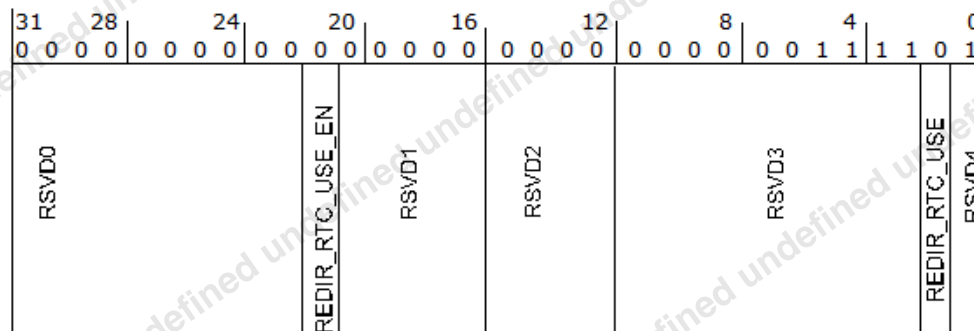
ILB_BASE_ADDRESS Reference: [B:0, D:31, F:0] + 50h

Default: 0000003Dh

Bit range	Default and Access	Field Name (ID): Description
31:22	0x0 RO	RSVD0
21	0x0 RW	REDIR_RTC_USE_EN: Redirect RTC Usage Enable: When this bit is set to 0, RTCC[1] can be used to redirect RTC usage to RTC circuits not affected by erratum CHP49
20:16	0x0 RW	RSVD1
15:12	0x0 RO	RSVD2

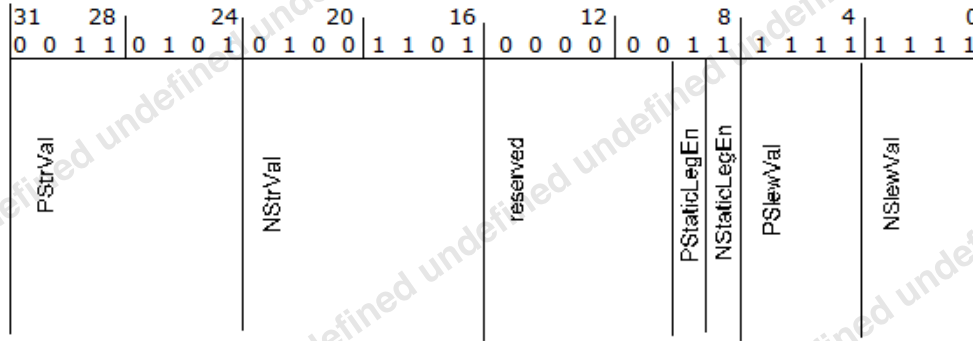
Default: 354D03FFh

Bit range	Default and Access	Field Name (ID): Description
7:4 ¹	0xf RW	P Slew Value (PSlewVal): Slew values for Pull-up settings.
3:0 ²	0xf RW	N Slew Value (NSlewVal): Slew Values for Pull-down settings.

1. For SD card IO family, bits [5:4] contain the PSlewVal, and bits [7:6] are reserved.
2. For SD card IO family, bits [1:0] contain the NSlewVal and bits [3:2] are reserved.
